## **CHAPTER 4 – RESULTS AND DISCUSSIONS**

PT XYZ has four Komatsu EXCAVATOR PC1250-8 units, which are used for production operational activities. In the agreement between the Operation team and the Maintenance team, the Maintenance team is required to be able to present unit performance in accordance with the agreement, namely a minimum unit availability value of 85%.

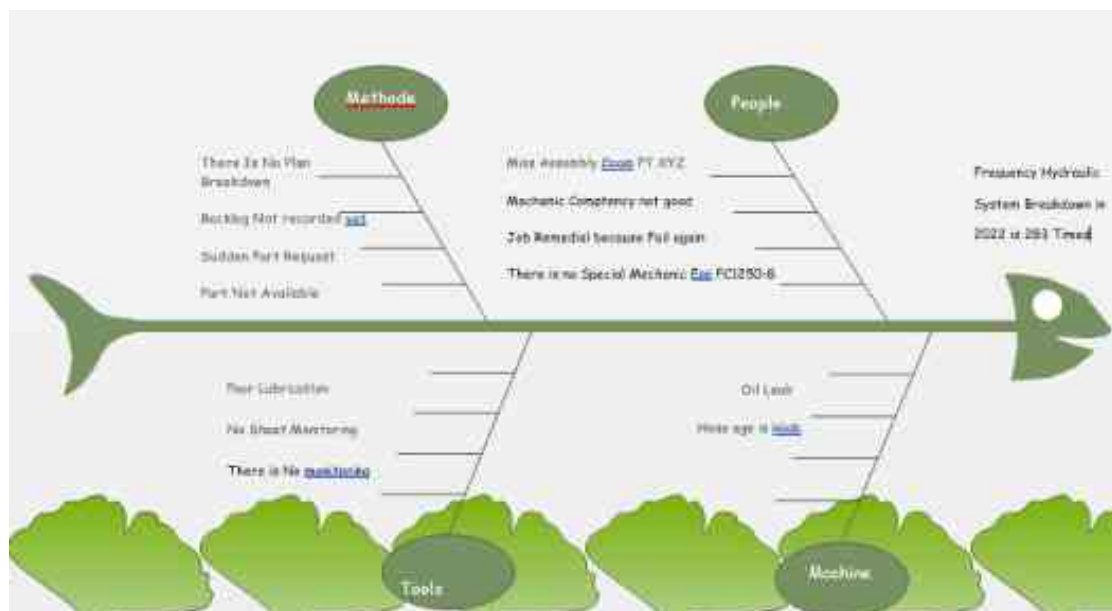
Figure 4.3 Fishbone Diagram Breakdown Hydraulic system

- 1 Machine: There is one factor from the machine side that causes the frequency of Hydraulic system in 2022 to be 283 times, namely 175 times root of the oil leak turned out to be the hose which more than 20.000 working hours old

- 2 Tools: The tools factor is also an important part that causes problems. The frequency of front axle breakdowns in 2022 is 50 times out of 283 times, namely Poor Lubrication, which is caused by the absence of monitoring and recording the actual condition of the Hydraulic system. This happens because there is no autolube monitoring sheet on the hydraulic system and backlog system components.

- 3 Method: The method factor that causes the problem is that the frequency of hydraulic system breakdowns in 2022 is 283 times is low part availability, because there is no coordination regarding the actual condition of the unit. So there is no preparation for procuring parts. If there is damage in the field, and components or parts are needed, the parts are not available on site. So it takes time to procure the part from the vendor. This condition will cause high downtime.

- 4 People: Miss Operation, which is caused by the unit operating refresh process not running. Mechanics also contributed 58 times out of 283 times hydraulic system breakdowns caused by Miss Assembly. Uneven competency is the cause of errors in installation (Miss Assembly). And there is no mechanic who focuses on monitoring the Komatsu Excavator PC1250

The results of the fishbone analysis showed that all the factors previously explained were interrelated, with process factors, namely because the maintenance program had not been well structured, resulting in poor monitoring of the condition of the front axle components, which caused breakdowns unschedule is high, and the main part that is the root of the main problem in the process sequence is the uneven competency of the mechanics.

- 2 Machine: Oil leaks are a problem with machine parts caused by the age of the hose, which on average is more than 20.000 hours of operation. By replacing hoses that are more than 10.000 operating hours old. To maintain availability, this hose replacement can be done in parts or not all at one time.

- 3 Tools: If poor lubrication is not handled immediately, it will result in high unit downtime, because it requires repair by the fabrication team. So that when poor lubrication occurs quickly, there must be a daily inspection carried out by a mechanic and an auto lube inspection form that guides the mechanic to carry out auto lube checks from the pump to the lubrication point.

- 4 Method: When an unscheduled breakdown occurs and the spare parts are not ready, it will cause the work lead time to be high. Because repairs cannot be carried out immediately, you have to wait for spare parts and support tools to be available. To overcome this, if abnormal conditions are found when carrying out daily inspections, they must be recorded and then immediately reviewed and prepared support equipment and mechanics for the work. Meanwhile, the Backlog form is not yet ready to be used to record findings so it needs to be made, then communicated to mechanics about how to fill it.

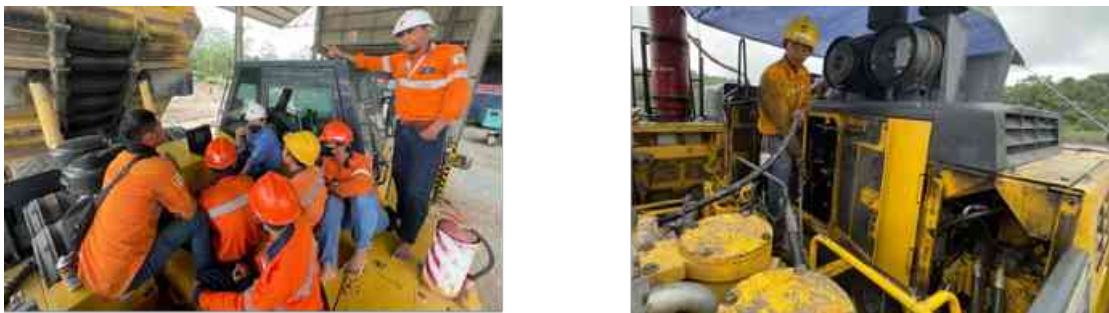
Figure 4.9 Procces Replacement Hose PC1250-8 in Hydraulic System

Improvements to the machine are by rejuvenating the hoses on the Hydraculic System. In Figure , the hose replacement process is carried out when the unit is serviced in the workshop. To maintain unit availability, this hose replacement is carried out in parts, or not at one time.

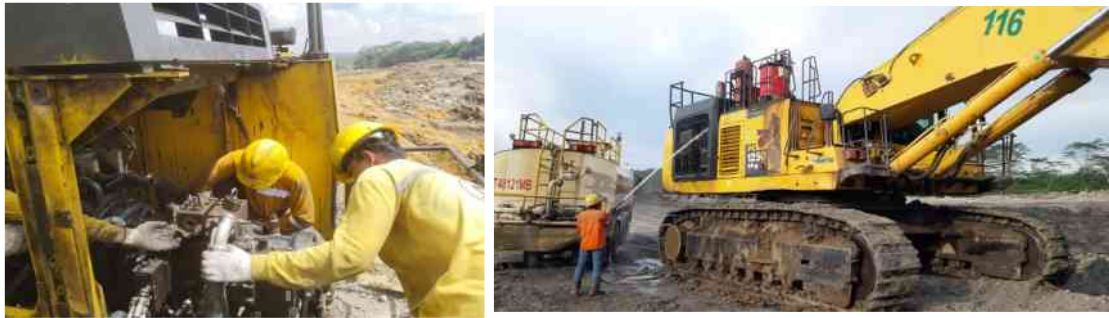
Figure 4.12 Daily check from mechanic and finding in PC1250 Hydraulic System

Figure 4.12 the daily inspection process carried out by a mechanic on the Komatsu Motor Excavator PC1250 unit. Along with the results of findings of abnormal conditions in the unit.
