## CHAPTER 4 - RESULT AND DISCUSSION

### 4.1 Mechanical Result

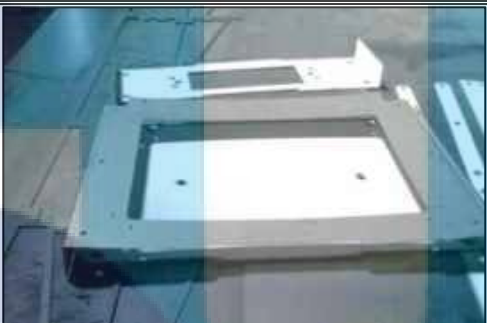
| Num. | Date | Component Description | Picture(s) |
|---|---|---|---|
| 1 | 21 <sup>st</sup> January | Machine Bed from AR Lasercut | |

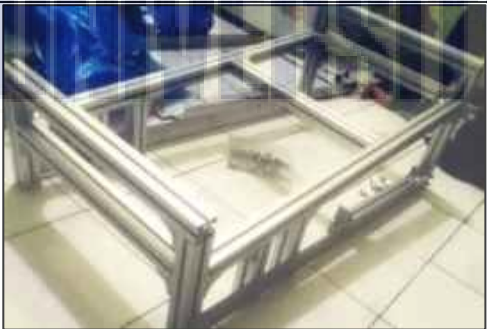
| Num. | Date | Component Description | Picture(s) |
|---|---|---|---|
| | | Aluminum Profiles assembled into structure | |

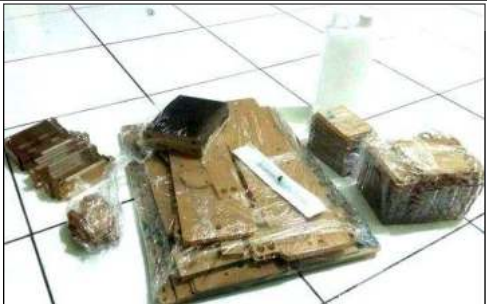
| Num. | Date | Component Description | Picture(s) |
|---|---|---|---|
| 3 | 7 <sup>th</sup> February | Acrylic Parts and Glue bought | |

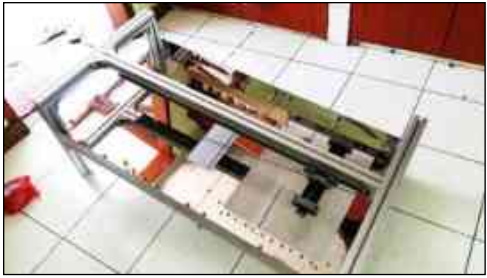
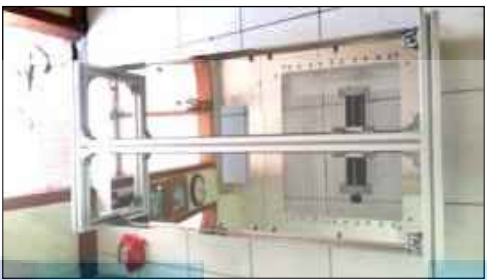
| 4 | 15 <sup>th</sup> February | Machine Bed already assembled and the protective stickers are peeled off | |

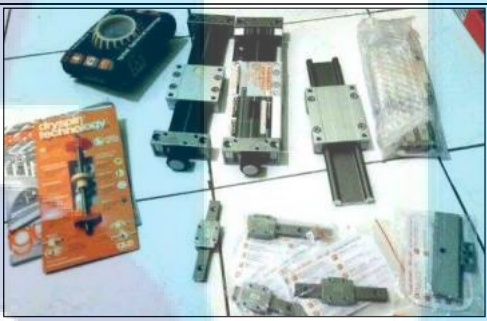
| 5 | 24 <sup>th</sup> February | IGUS Linear Guide samples | |

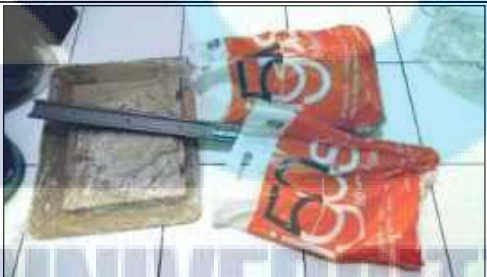
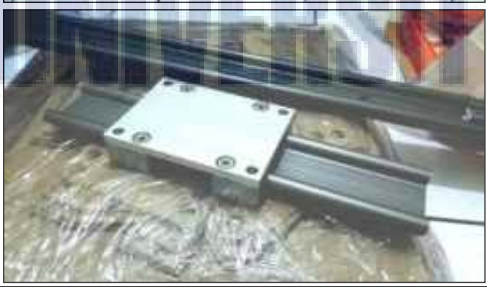
| | | IGUS Linear Guide bought and additional Acrylic Parts bought | |

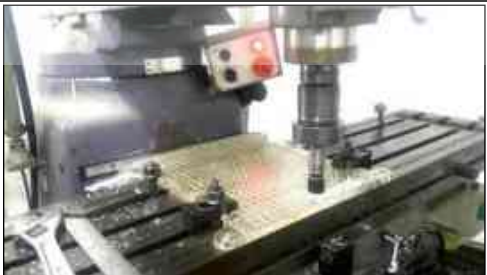
| 6 | 12 <sup>th</sup> March | Clamp with slits is machined using conventional milling machine | |

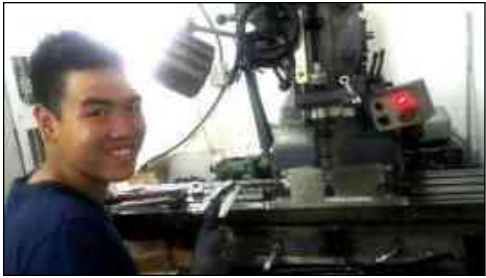
| 6 | 12 <sup>th</sup> March | Clamp with slits is machined using conventional milling machine | |

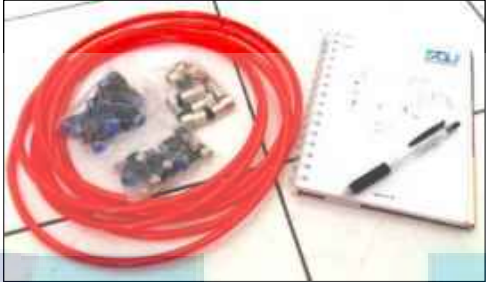
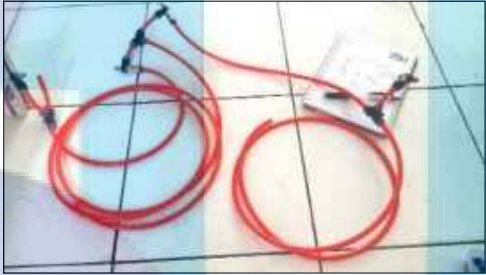
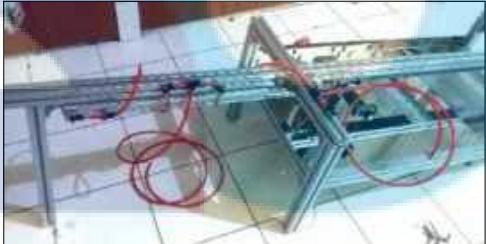
| 7 | 17 <sup>th</sup> March | Pneumatic System piping and valves designed, assembled, and integrated into the machine | |

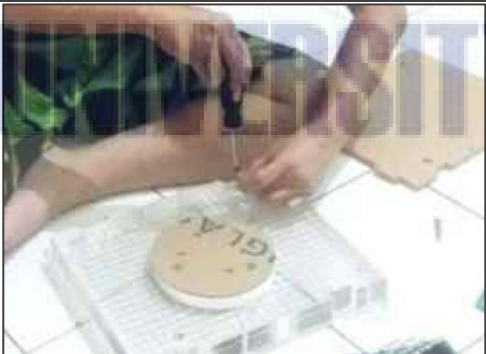
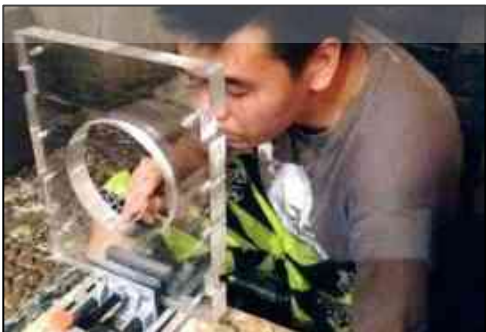
| 8 | | Clamping Module assembly and post-processing | |

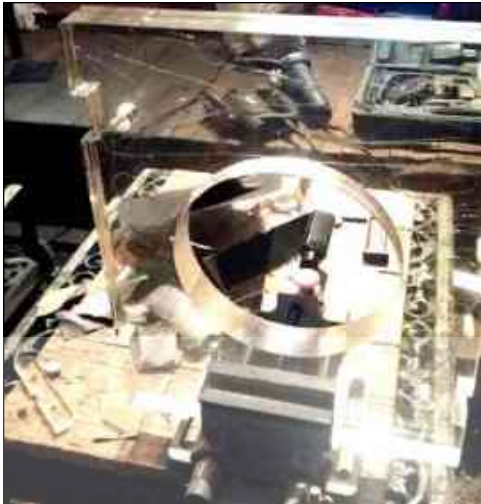
| 8 | 17 <sup>th</sup> March | Clamping Module assembly and post-processing | |

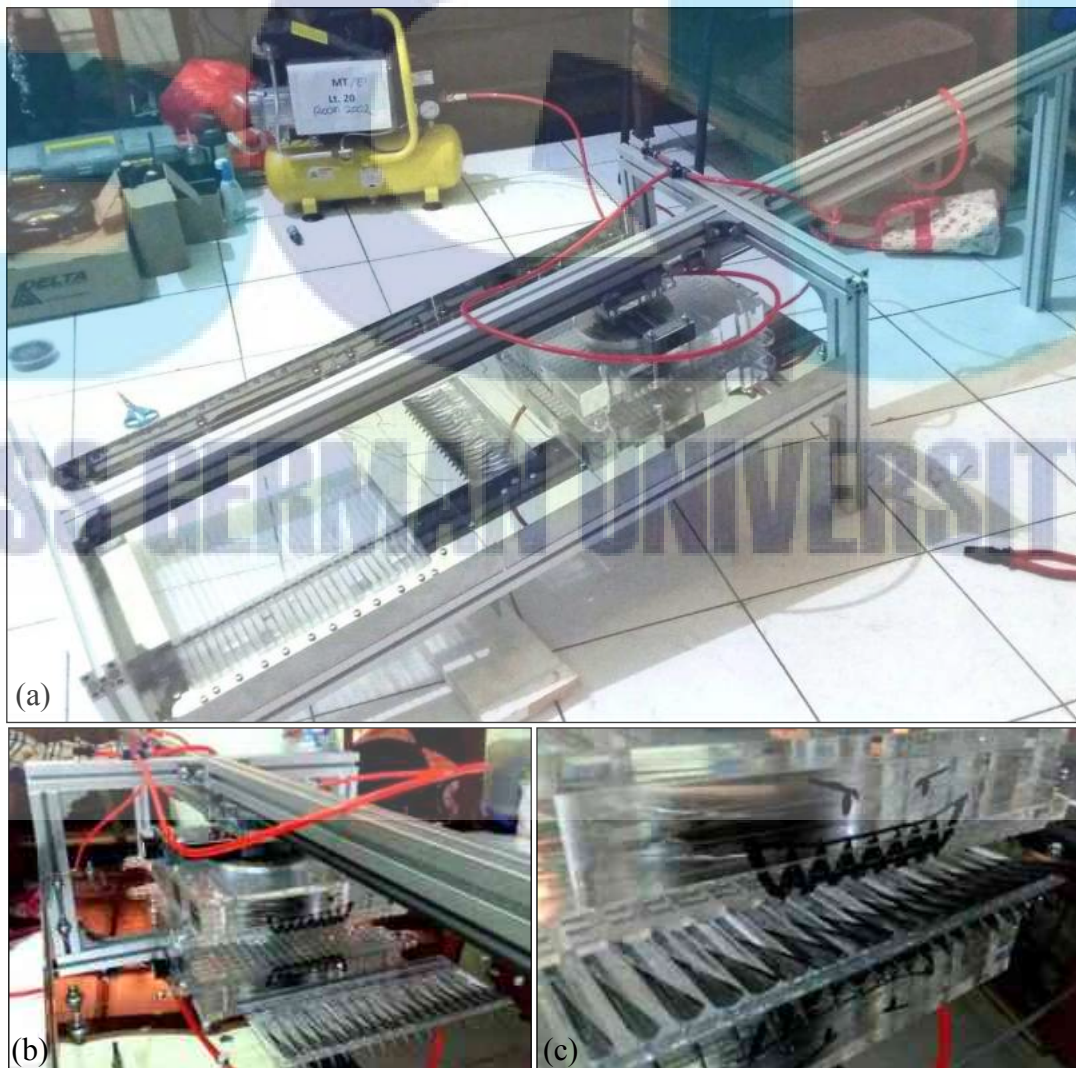
After all of the components are assembled, on 4 April 2017, the completely assembled *nata* cutting machine is ready for doing the designated tests.

Figure 4.1 – Finished *nata* cutting machine: (a) the whole machine, (b) clamping module close up, (c) blades close up.

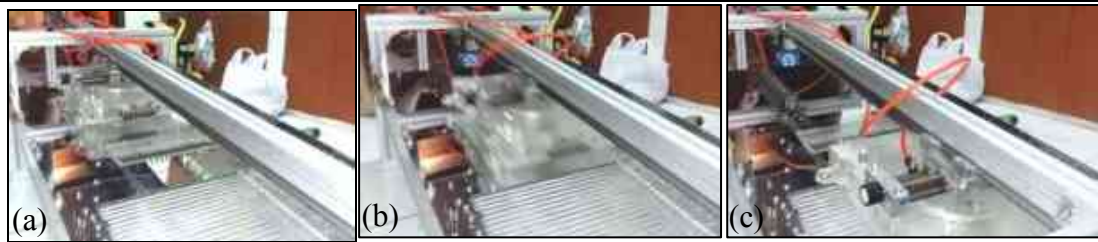
Figure 4.8 – The result for clamping mechanism: (a) initial, (b) advances, (c) final

The cylinder advances very well and very fast without any collision. However, the custom adapter for between the linear guides, which connects the clamp with X-cut cylinder piston rod, cracks instantly on the first try.

The clamp cannot be retracted automatically even if springs already implemented. It is expected a spring return condition will happen. Due to the manufacturing is not precision, the tolerances between the top part of the clamp and the bottom side are very poor, thus resulting in a great deal of friction between the bolt stopper and the clamp wall, which cannot be fought using small springs.

The custom adaptor cracks instantly due to the momentum of the clamp. The movement was very fast and the clamp itself, after embedded with a pneumatic system, weighs too high. Moreover, there is no stopper whatsoever which can absorb the momentum. Not to mention, the custom adapter is made out of acrylic, which is very brittle. Heavy weight, high velocity, no stopper, and the acrylic material is not a good combination.

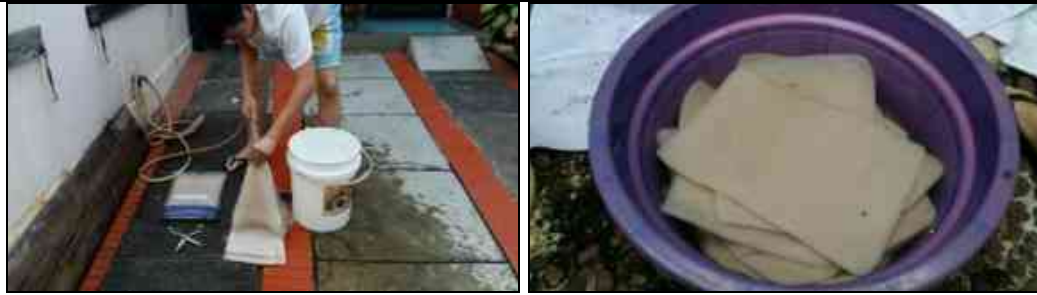
Figure 4.11 – The sample soaked in water to soften the texture

For the testing on 5 April, the sample *nata* is soaked in the water first before being cut. This is to remove the acidic preservatives which make the nata tend to be denser. It is expected that the osmotic phenomenon can soften the sample and makes it more alike with the commercial product often found in mini markets.

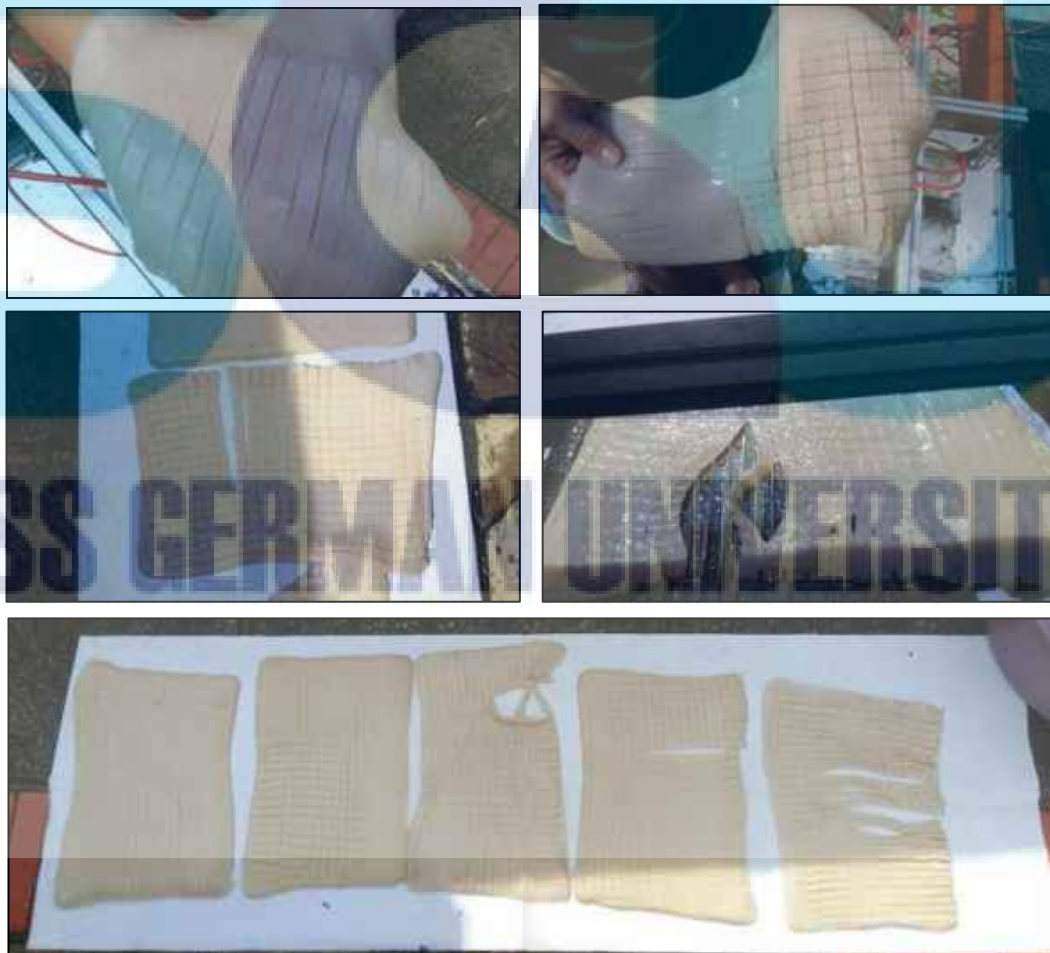
Figure 4.12 – Second test result photos

All *natas* are still being dragged by the blade. However, the results suggested that the method is legit because it still can make square cuts even though the *natas* are dragged along.

From the testing results above, it can be concluded that the clamping surface is uneven because sometimes it cuts well; sometimes some part of the sample is dragged along. The blades sharpness also has an influence. The result of the cut is not cubic; it is more like half circles. These mean the *nata* are being compressed rather than cut.

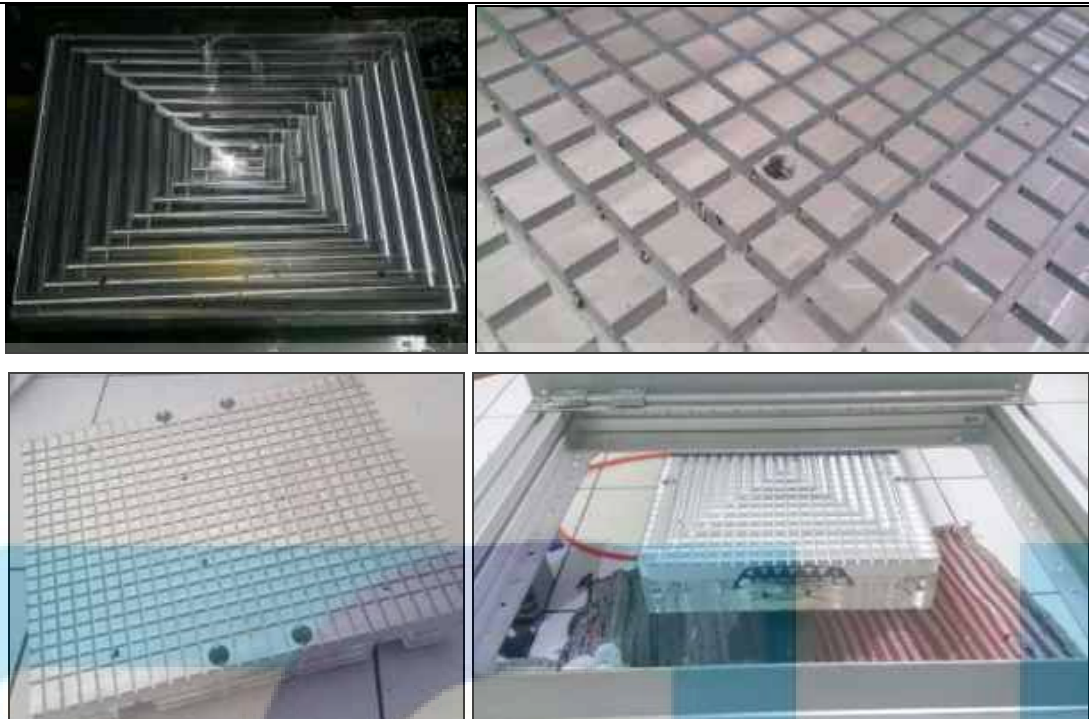
For the clamp problem, the material is interchanged from acrylic to aluminum. When using aluminum, the maximum deviation when pressurized with two bars is only 0.2 mm. The clamp design then subbed out to be CNC-milled.

Figure 4.13 – The new clamp made out of aluminum

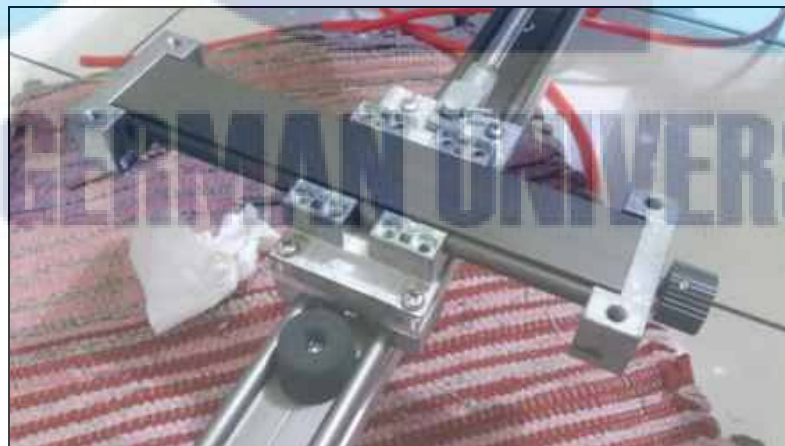
Because the clamp is now made out of aluminum, the momentum should have gone much bigger, since the mass of the clamp itself has been quadrupled than before. Therefore, a rubber stopper is now installed to absorb the momentum.

Figure 4.14 – Rubber door stopper to absorb the momentum

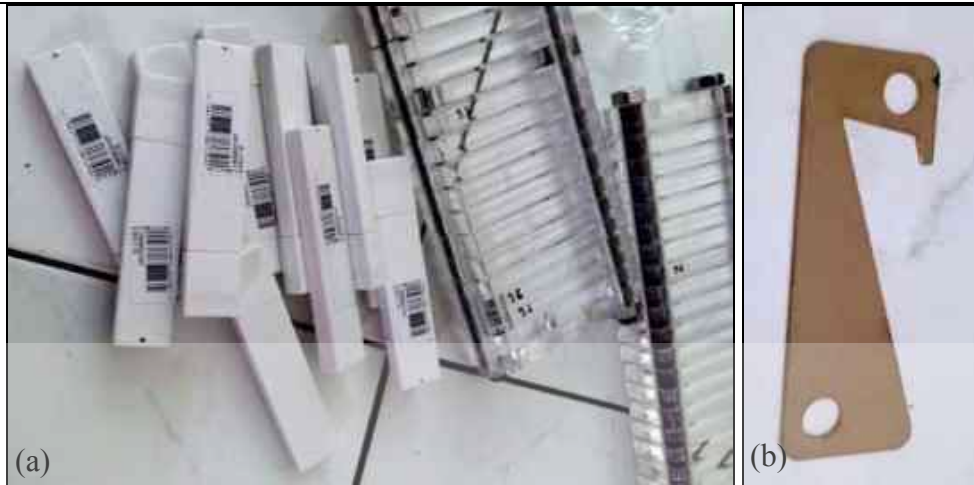
For the blades problem, the blades are changed into the paper cutter, just like The Apparatus from Chapter 3.7 Preliminary Concept Testing. The property of food safety has to be neglected to achieve the blade sharpness of a paper cutter.

Figure 4.15 – The blades are (a) changed into paper cutters with (b) new jigs

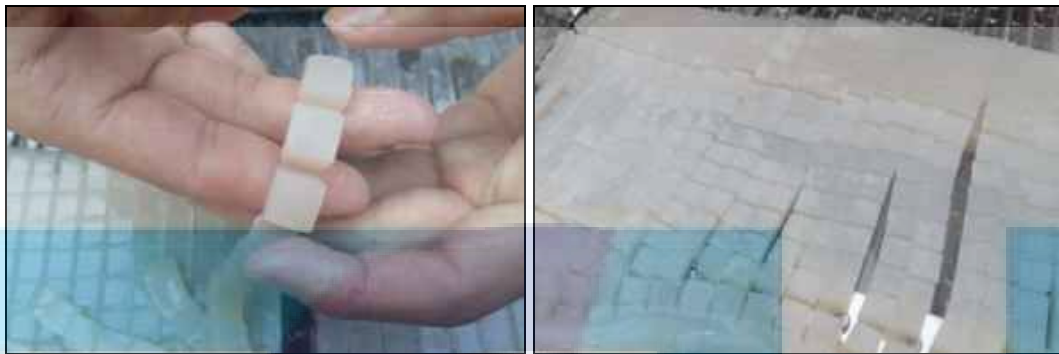
Figure 4.16 – Third test result photos

The result is very good, the *cubicness* is achieved, but most of the results from X-cut are still connected by a very thin layer. The cycle time in average is 15 seconds. The cutting process was done four times, which in the last one; the clamp height is reduced by 2 mm. However, the result is still the same; most of the X-cut results are still interconnected.

The results for Y cut are all perfect.

The X-cut result behaves as that may be caused by the varying sample thickness. The solution is to lower the clamp again or increase the clamping force by increasing the pressure going into the clamping cylinder.

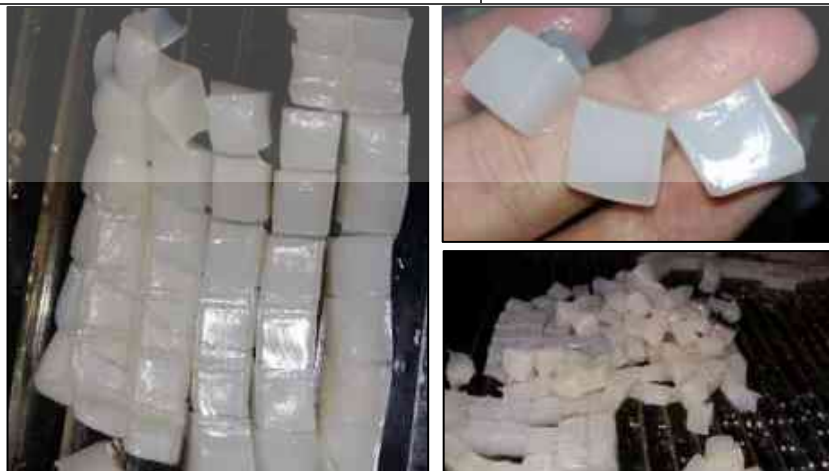
Figure 4.19 – Fifth test result photos

The result of this testing is almost perfect, only the noodles are shifted when entering the Y cut area because it goes through a set of slits while being clamped. To smoothen the entering of the nata sheet into the Y cut area, a transfer plate has to be added. A transfer plate is an additional plate acting as a temporary flooring, which has the same height with the bed.

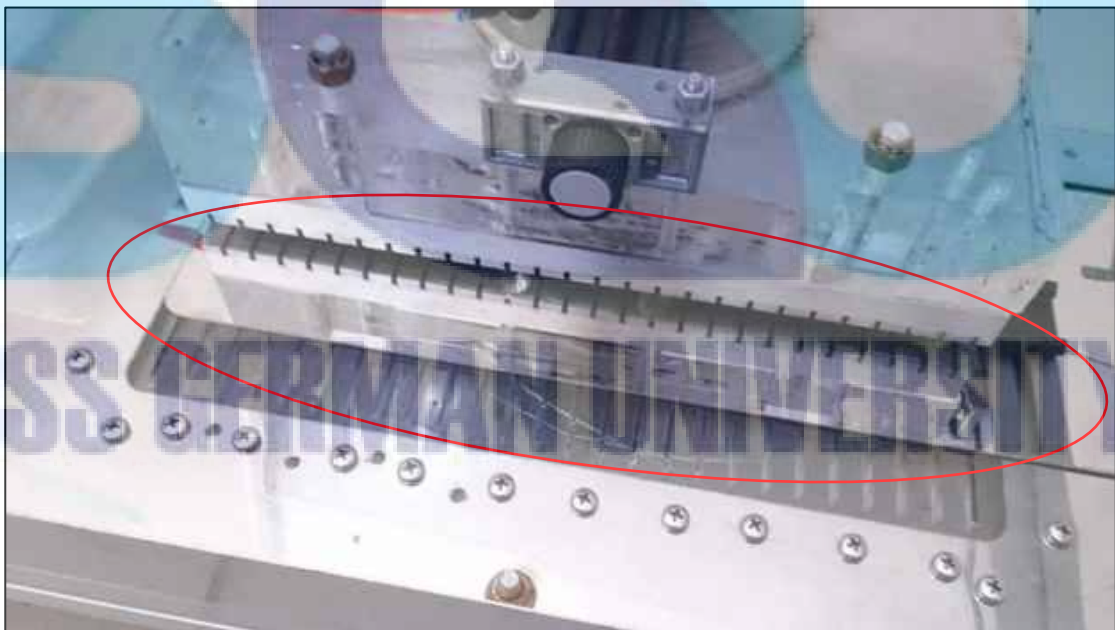
Figure 4.20 – The implementation of transfer plate

A new transfer plate is used, placed on top of the Y cut area, and then removed after the nata enters the area perfectly.

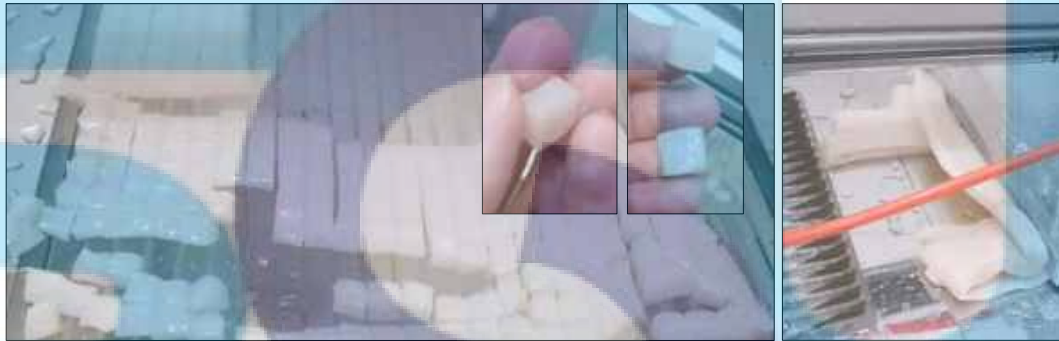
Figure 4.21 – Sixth test result photos

The result for the sixth test is perfect with minor problems. For the cutting, it is perfect already. Both X cut and Y cut has perfectly cut all the way through the *nata* (no more connected pieces). However, some of the *nata* noodles ( $\pm 30\%$ ) were tucked away in X cut area, because X area is lower than the bed by one millimeter. The area must be leveled off.

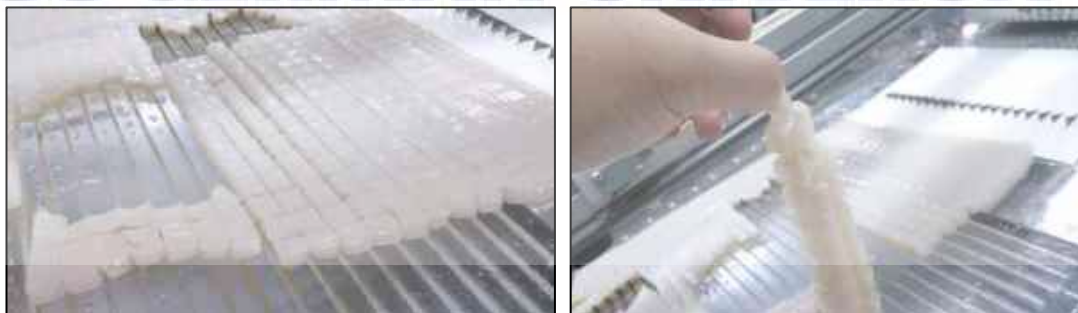
Figure 4.23 – Seventh test result photos

Unfortunately, even after all variables have been dealt with, actuators with high pressure also has been implemented; the result has gotten way much worse. The X cut

works smoothly, with cycle time below 3 seconds (the X cut cylinder was supplied with six bars of pressurized air). However, the result was still connected each other, even worse than before, when it also was connected. To top it off, the Y cut, which usually has no issue, at that moment was having a big issue: it requires very big force, to the point it is very hard to be pulled by one hand. It must have something to do with the blades sharpness. It turns out; all of the blades have become dull. It has to be replaced.
