**IMPROVING ENGINE COOLING SYSTEM TO PREVENT OVERHEATING  
IN MOTOR GRADER USING IOT**

MASTER'S DEGREE  
in  
MECHANICAL ENGINEERING – ENGINEERING MANAGEMENT  
FACULTY OF ENGINEERING AND INFORMATION TECHNOLOGY

SWISS GERMAN UNIVERSITY  
The Prominence Tower  
Jalan Jalur Sutera Barat No. 15, Alam Sutera  
Tangerang, Banten 15143 – Indonesia  
**Revision after the Thesis Defense on August 19, 2025**

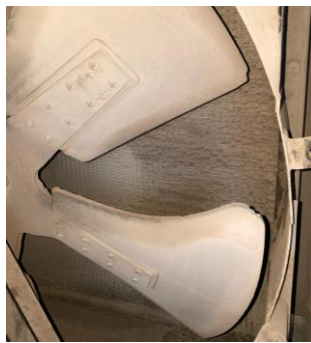
Figure 4 Dusty Radiator

The working principle of a 4-stroke engine consists of intake stroke, compression stroke, power stroke, and exhaust stroke. When the combustion process occurs in the combustion chamber, precisely in the compression stroke, the temperature reaches 400~500°C (Yuni, 2021). Working environment conditions with air temperatures above 30 degrees celsius coupled with exposure to dust on the hauling road are challenges that must be faced in the field. In such conditions, the cooling system on the motor grader engine often have problems that trigger overheating due to dust accumulation, especially in the radiator area as show in the Figure 4.

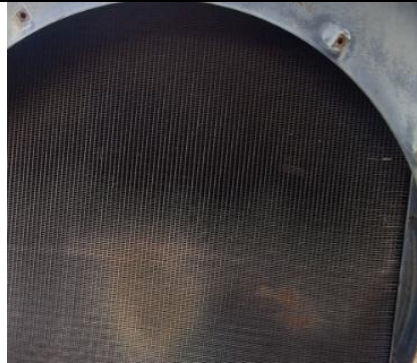
Figure 10 Radiator

Figure 10 shows that this component is equipped with aluminum fins. This significantly increases the surface area for the cooling process using the help of a fan that is rotated by the engine using a belt. The efficiency of this heat-exchange process relies considerably on radiator design, material selection, and coolant composition, each influencing the radiator's ability to effectively absorb and disperse heat from the engine (Habeeb *et al.*, 2020).

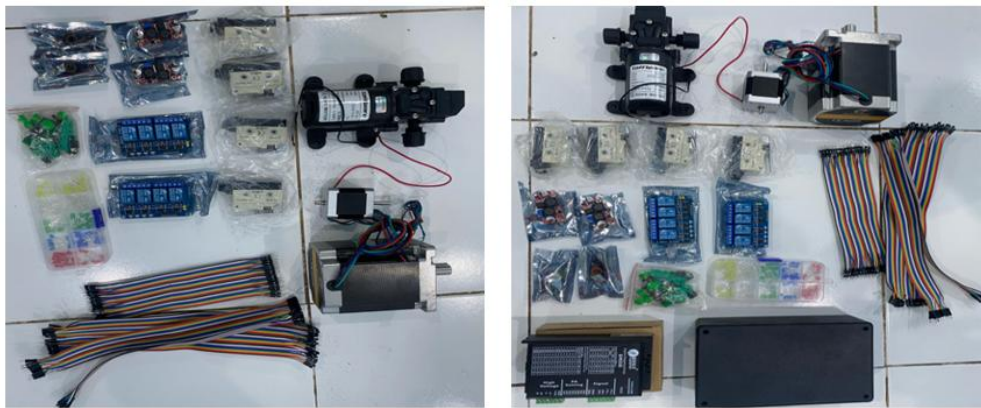
Figure 32 Electrical Component

Figure 32 shows the electrical component. At this stage, the stepper motor is attached to the track rail to move the nozzle horizontally and vertically. Limit switches are installed at each track limit point to detect the final position of the nozzle and change its direction of motion. The water pump is connected to a hose from the water tank, and connected to the nozzle. The push button is installed inside the cabin and connected to the controller system via a heat-resistant cable.

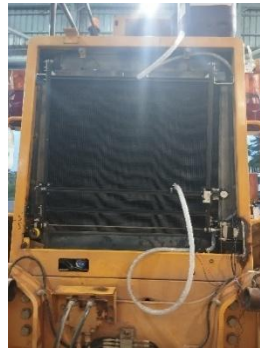
Figure 34 Final Design

Figure 34 shows the final design. After initial testing, adjustments are made to the nozzle position and motor speed to ensure even spray coverage. The system is tidied up, electrical connections are secured using cable protectors (conduits), and technical documentation is carried out as part of the standardization of system implementation.

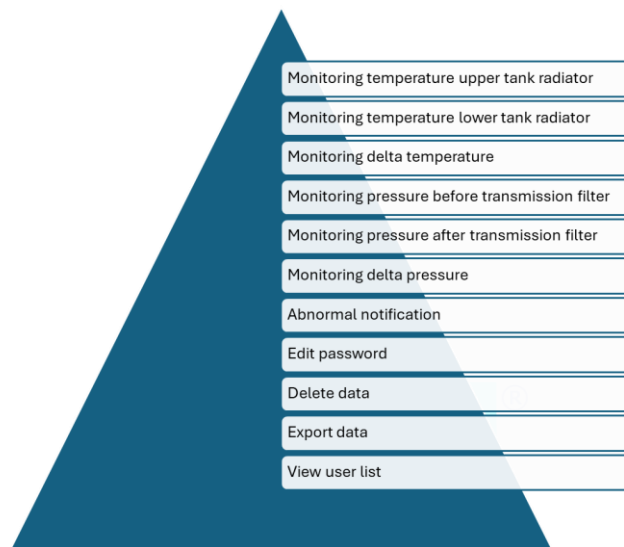
Figure 35 Features of Application

This application is designed to support comprehensive cooling system monitoring by providing crucial features that focus on temperature and pressure parameters like shown in the Figure 35. Among them are temperature monitoring on the upper and lower radiator tanks accompanied by delta temperature calculations as an indicator of the effectiveness of the cooling process. The system also facilitates monitoring of pressure before and after the transmission filter, allowing delta pressure calculations as an early signal of decreased performance or blockage of the lubrication system. The automatic warning function will be activated when the parameter reaches a potentially dangerous threshold value. In addition to these technical features, this application is also equipped with administrative functions, such as user access management, password changes, deletion and export of data, and display of user lists. All of these features are integrated
